# 2016 SOUTH FLORIDA Environmental Report

## HIGHLIGHTS

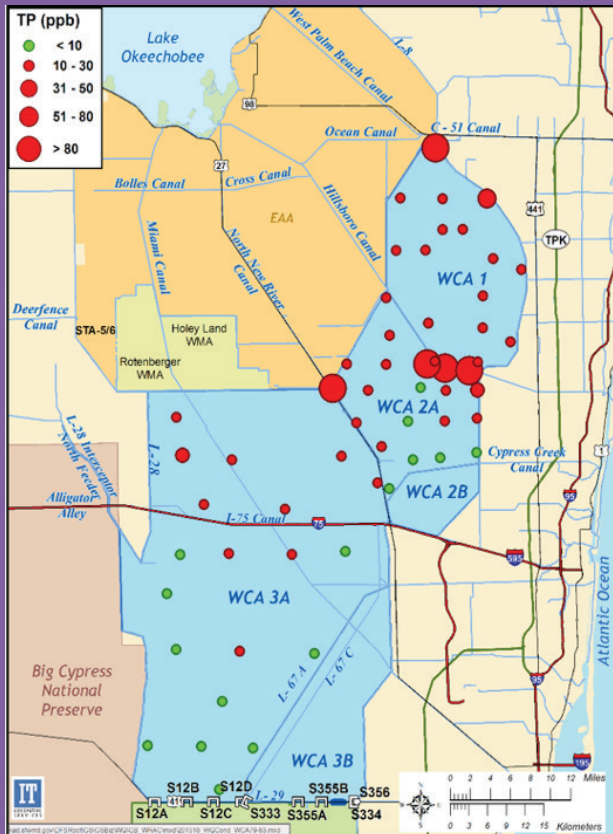
1979 - 1983

**Left:** Prior to restoration efforts, cattail growth in the Water Conservation Areas, fueled by excessive levels of phosphorus, choked out native plant communities and disrupted food sources and habitat for endangered wildlife. The red dots show areas measured with excessively high levels of phosphorus.

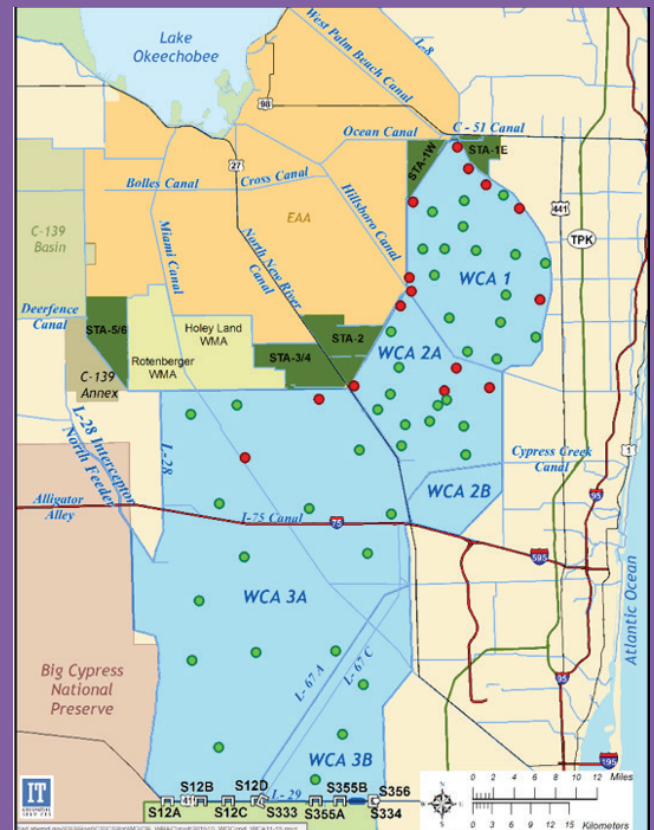
2011 - 2015

**Right:** In 2015, with operation of 57,000 acres of stormwater treatment areas and implementation of best management practices, water quality throughout the Water Conservation Areas has been substantially improved. The green dots show areas that have been restored to ecologically healthy water quality. The handful of sampling stations that are not at 10 ppb (red dots) are continuing to make significant progress in achieving that standard. Notably, six stations in the Water Conservation Areas previously identified as "impacted" transitioned to an "unimpacted" status in WY2014 and have maintained that status in WY2015. Overall, 90 percent of the Everglades is at or below 10 parts per billion of phosphorus.

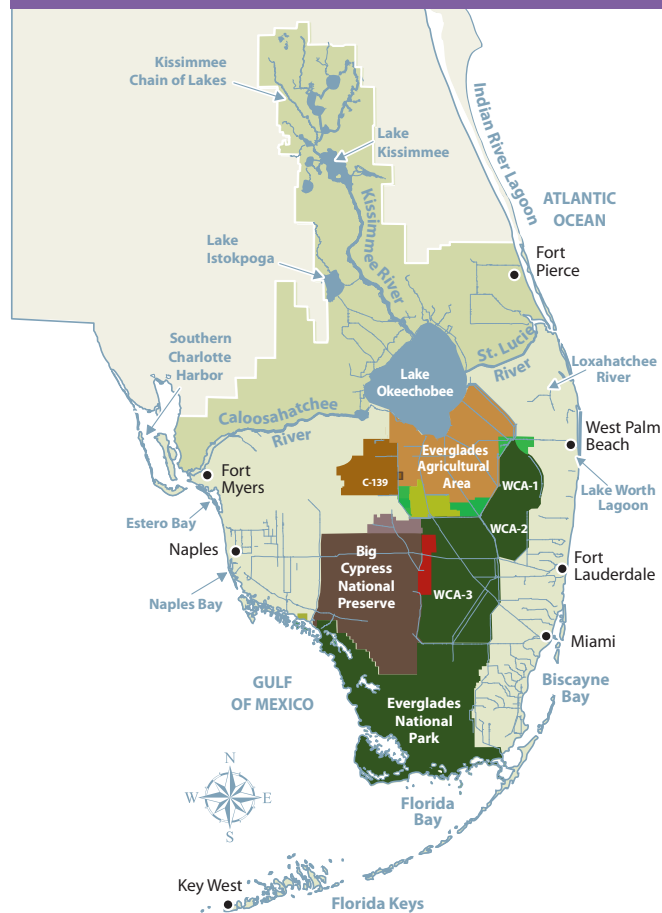
Stormwater treatment areas (STAs) are large, constructed wetlands with inflow and outflow structures for controlling water movement. Aquatic plants in the STAs remove and store excess nutrients (phosphorus) found in the stormwater runoff through growth and the accumulation of dead plant material in the layers of sediment. This natural process cleanses the water before it is moved out of the STA and into the Everglades or other water bodies.

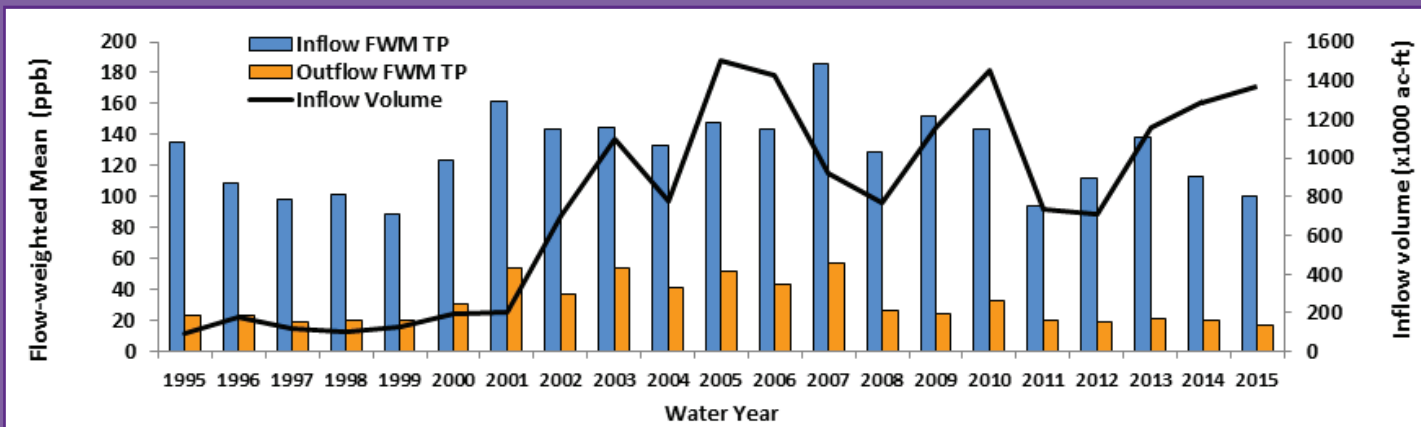
**Everglades stormwater treatment areas working to clean water:** Since 1995, approximately 16 million acre-feet of water have been treated by the South Florida Water Management District's five stormwater treatment areas (STAs) – that's enough to cover all 16 counties within the District with 1.25 feet of water. The STAs use nature's own green technology, plants, to remove excessive phosphorus before it enters the Everglades. In 2015, water entering (inflow) the STAs averaged 99 parts per billion, and water leaving the STAs to the Everglades (outflow) averaged 17 parts per billion, the lowest level since the start of their operations. To date, 2,012 metric tons of phosphorus were removed through STAs.

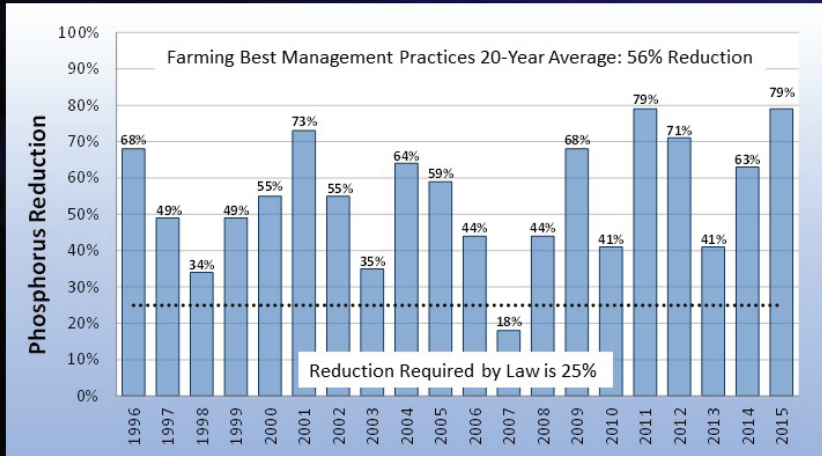
**Farming Best Management Practices (BMPs) curb phosphorus runoff at the source:** The 20-year average decrease of 56 percent reduction (compared to pre-water quality efforts) in phosphorus runoff from the Everglades Agricultural Area farming is more than double the improvement required by state law. In 2015 alone, phosphorus runoff from the EAA was reduced by 79 percent versus the prior year. To date, 2,900 metric tons of phosphorus were prevented by BMPs from flowing to the Everglades.

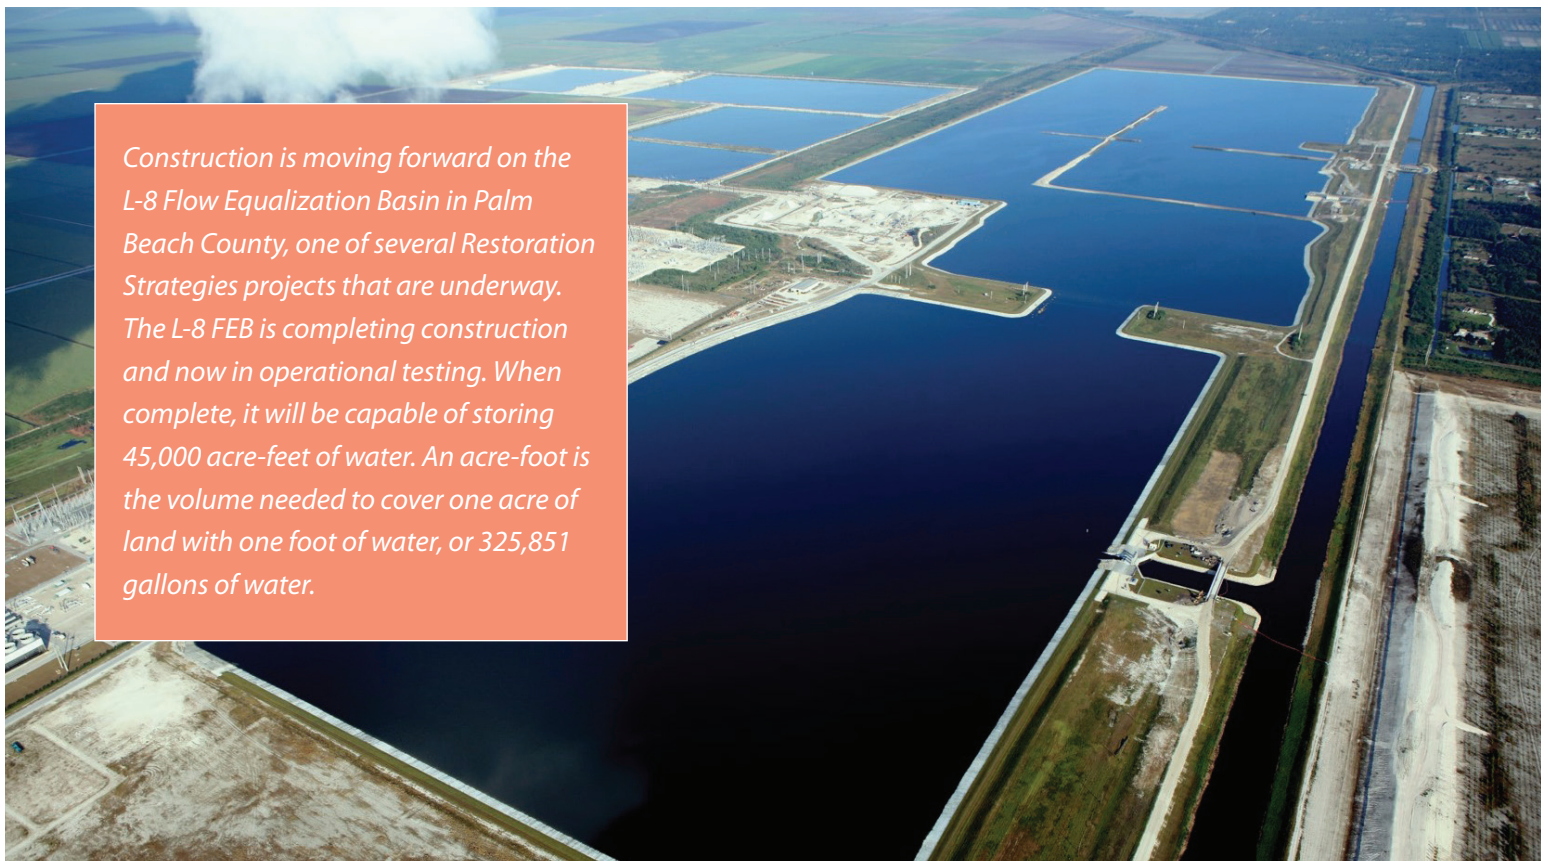
Construction is moving forward on the L-8 Flow Equalization Basin in Palm Beach County, one of several Restoration Strategies projects that are underway. The L-8 FEB is completing construction and now in operational testing. When complete, it will be capable of storing 45,000 acre-feet of water. An acre-foot is the volume needed to cover one acre of land with one foot of water, or 325,851 gallons of water.

- L-8 FEB (a 45,000 acre-foot deep storage impoundment) is completing construction and now in operational testing.
  - STA-1 West Expansion (an additional 4,300 acres of treatment area) design was completed in June 2015 and construction

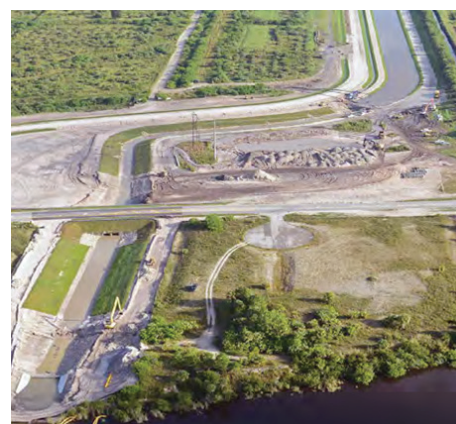
**Florida expedites construction:** The C-44 Reservoir and Stormwater Treatment Area project in Martin County will provide 50,600 acre-feet of storage to capture and treat local basin runoff to protect the St. Lucie Estuary.

Nicodemus Slough, Boma Property, North Six Mile Cypress Slough and Mudge Ranch. Regional projects with both water storage and water quality benefits also progressed. For example, expedited construction began on the Comprehensive Everglades Restoration Plan Indian River Lagoon South – C-44 Reservoir/STA (St. Lucie Watershed) Project to help improve water quality in the St. Lucie River and Estuary.

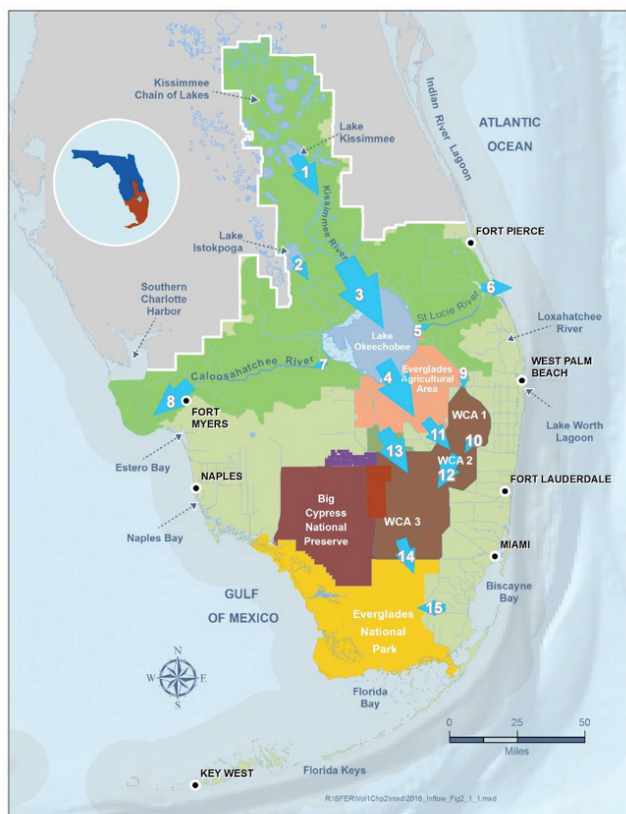
Map ID	Water Body	WY2015 flows (ac-ft)	WY2014 flows (ac-ft)
1	Lake Kissimmee Outflows	1,170,556	765,563
2	Lake Istokpoga Outflows	446,215	319,317
3	Lake Okeechobee Inflows	2,831,832	2,695,257
4	Lake Okeechobee Outflows	1,933,353	2,527,633
5	Flows into the St. Lucie Canal from Lake Okeechobee	129,227	444,651
6	Flows into the St. Lucie Estuary through the St. Lucie Canal	188,236	675,800
7	Flows into the Caloosahatchee Canal from Lake Okeechobee	575,971	1,225,613
8	Flows into the Caloosahatchee Estuary through the Caloosahatchee Canal	1,234,173	2,521,600
9	Water Conservation Area 1 Inflows	245,360	380,269
10	Water Conservation Area 1 Outflows	198,051	471,206
11	Water Conservation Area 2 Inflows	823,996	1,078,408
12	Water Conservation Area 2 Outflows	810,056	965,358
13	Water Conservation Area 3 Inflows	1,312,417	1,248,362
14	Water Conservation Area 3 Outflows	779,167	1,452,583
14,15	Everglades National Park Inflows	1,015,301	1,590,971

**Managing rainfall (hydrology) in 2015:** While overall rainfall in Water Year 2015 was slightly below average, its distribution across the region was uneven, creating many water management challenges. In particular, the Lake Okeechobee watershed was very wet, resulting in far above average inflows and outflows of the lake — both 134 percent of their historical average.

- While overall rainfall in Water Year 2015 was slightly below average, its distribution across the region was uneven, creating many water management challenges.** In particular, the Lake Okeechobee watershed was very wet, resulting in far above average inflows and outflows of the lake — both 134 percent of their historical average. In response, Lake Okeechobee rose more than 3 1/2 feet during the wet season (reaching 16 feet NGVD in October triggering freshwater regulatory releases to the Caloosahatchee and St. Lucie estuaries). The South Florida Water Management District, Florida Department of Environmental Protection and other agencies met weekly to discuss the state of the regional system and develop operational recommendations to the Corps. With conditions drier than normal south of the lake, the Everglades STAs had treatment capacity available, and unprecedented operations sent lake releases into the STAs for treatment prior to discharge to the southern Everglades. Lake outflow was 1.9 million acre-feet, with roughly a third (0.7 million acre-feet) discharged to the estuaries and the remainder directed southward.

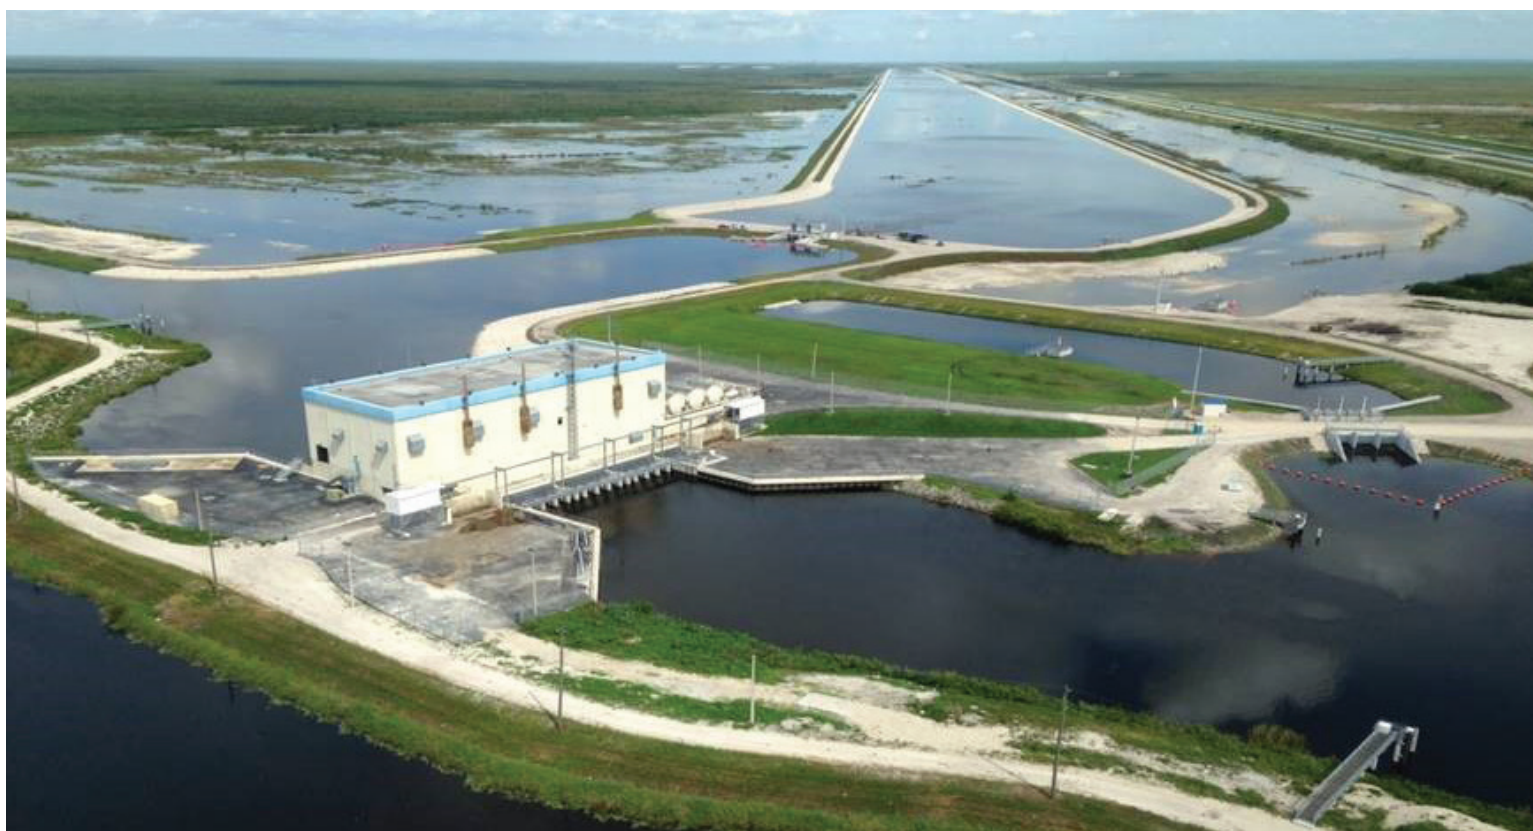
**Optimizing system performance:** Completed ahead of schedule in November 2015, the A-1 Flow Equalization Basin in Palm Beach County, which is part of Florida's Restoration Strategies Plan for clean water for the Everglades, assists in optimizing the performance of two nearby stormwater treatment areas in removing phosphorus. It can hold up to 60,000 acre-feet of water up to 4 feet deep, and then delivers water in a controlled manner to the treatment areas. It is surrounded by 21 miles of levees and has 15 associated water control structures.

- A-1 FEB (a 60,000 acre-foot shallow storage impoundment) construction was completed in November 2015 (more than six months ahead of its deadline) and operations have commenced.
